MASSIMILIANO PANESSA
Yacht & Small Craft Surveyor

Report nr. Condition
Date of inspections: 00000
Where inspected:: Località
Address
Customer: Mr. Nome
Address
Kind of survey: Pre purchase

Inspection report
Auxiliary Engine Sailing Yacht named:

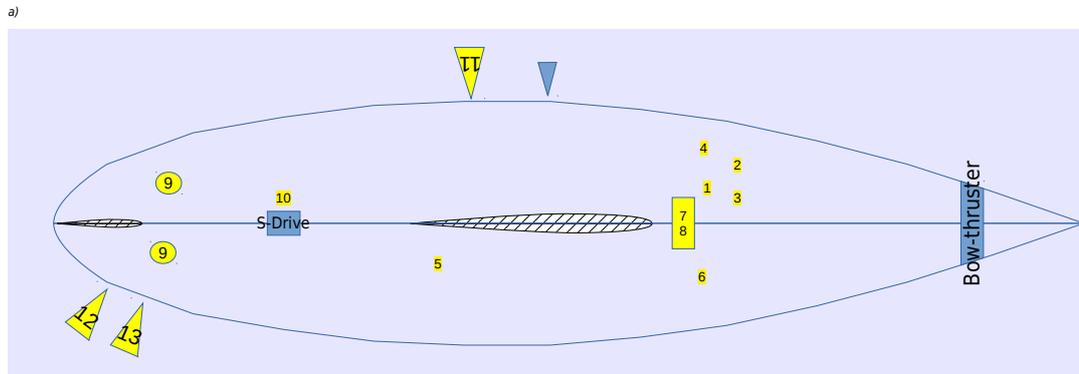
Diagram 3.1.a - Skin fittings identification

- (1) Heads inlet: Yellow metal thru-hull fitting with strainer and ball valve. This is seized and in very poor condition. Owner advised he didn't know it was there, and never closed it. It should be replaced. Hoseclips are corroded and should be replaced at the same time. Access under companionway steps.

- (2) Heads discharge: Yellow metal thru-hull fitting with ball valve, this too is seized. Similar to the inlet, this should be replaced. Hoseclips are corroded and should be replaced at the same time. Access under companionway steps. Heads discharge under saloon sole

- (3) Heads Basin outlet: Yellow metal thru-hull fitting with ball valve in working order and in satisfactory condition. Access in cupboard in heads compartment.

- (4) Shower outlet: Yellow metal thru-hull fitting with ball valve in working order and in good condition. Access in cupboard in heads compartment.
- (5) Galley sink outlet: Yellow metal thru-hull fitting with ball valve. This seized and in poor condition. Access is limited and another seacock that the owner claims he never turned off. The pad onto which the valve is mounted is disintegrating, and is believed to have electrochemical decay possibly from a disconnected bonding wire lying nearby. Both the valve and the pad should be replaced. There is much divided opinion on Cathodic protection and the latest view is to leave seacocks out of the bonded circuit. (You may find useful this [Sail Magazine article](#), or other similar). Hoseclips are corroded and should be replaced at the same time. Access in cupboard under sink on the starboard side of the fridge unit.

- (6) Fridge intake for water cooled fridge compressor: Valve located in the single cabin, the ball valve is very stiff and should be serviced or replaced. Fitting on aft port quarter: There is another fitting seen close to the waterline here externally. It was not possible to identify this internally and access should be obtained to examine the fitting.

- (10) Saildrive engine intake: Ball valve in good condition

- (11) Bilge pump: Exits via a nylon thru-hull fitting well above sea level and secure.
- (12) Eberspächer: Stainless steel fitting secure and in good condition.
- (13) Engine Exhaust: Stainless steel fitting in good condition and secure

The skin fittings/valves/tailpipes on this vessel are all yellow metal (except log and transducer) but the actual materials could not be identified. Their condition should be monitored and valves operated frequently. If any deterioration, corrosion or leakage is noted the fitting should be replaced.
